EcoNet[®]
Smart. Simple. Savings.

TROUBLESHOOTING GUIDE

ECONET ENABLED UNIT COOLERS

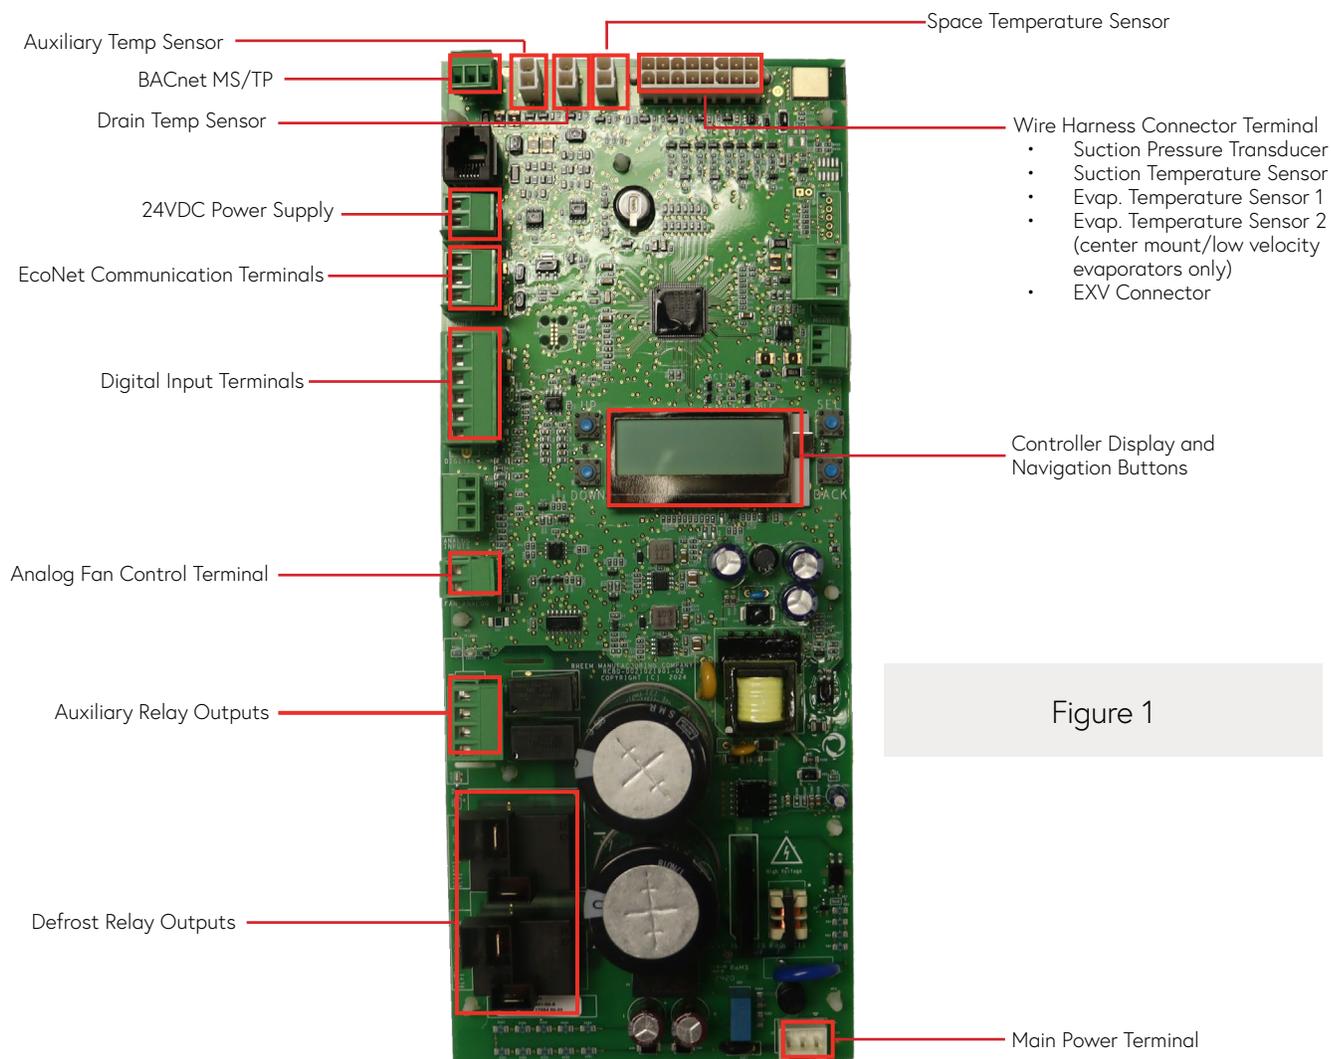
Figure 1

ECONET BOARD

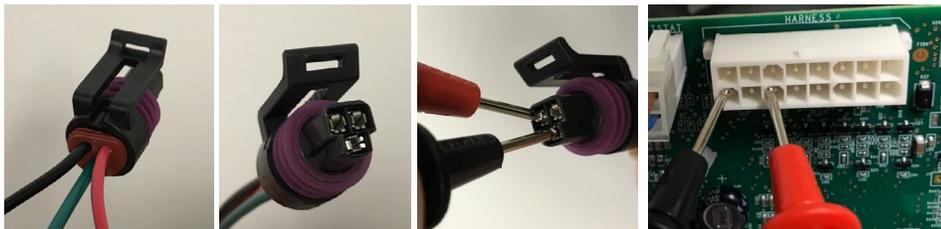
Suction line at compressor is icing up excessively.	Suction Pressure transducer disconnected, or transducer could be malfunctioning/reading erratic value.	<p>Verify if Suction Pressure alarm is active: on controller display go to Service→Current Alarms. Also verify Suction Pressure reading under Status→Sensors→Suction Pressure; if it is reading "-14.7 PSIG", the sensor is malfunctioning or is disconnected. If the controller detects that the pressure input is missing, alarm "A106 Suction Pressure Sensor Failure" will be active and the red LED above the display will be flashing to indicate active alarm. The controller will attempt to calculate approximate superheat by using Evap Temp 1 reading instead of Saturated Suction Temp and continue metering the EXV, but the calculated superheat will not be as accurate. Replace Suction Pressure Transducer (part no. 08219621).</p> <p>Inspect wire harness for visible wire damage. Replace harness if damaged. Refer to page 48 of EcoNet Installation Manual for wire harness replacement part numbers.</p> <p>Verify +5VDC power supply from controller to pressure transducer. Disconnect pressure transducer from harness. Use a voltmeter to measure DC volts between RED and GREEN wires on the harness connector as shown below. Alternatively, DC volts can be measured between the 1st and 3rd pins from left to right on the bottom row of the board connector as shown below. If voltmeter is reading a different value than +5VDC, replace EcoNet controller (part no. 08536930). SEE IMAGES BELOW FOR REFERENCE</p>

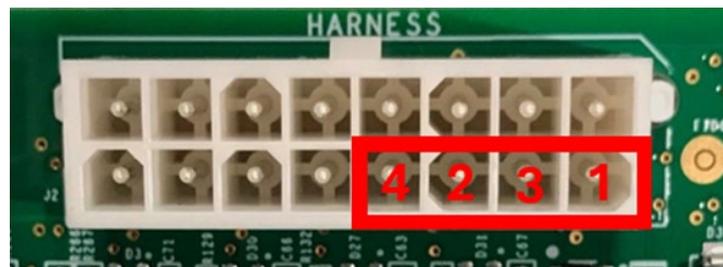
Pins 1 & 3

VERIFY CONTROLLER SIGNAL TO BI-POLAR VALVE

- 1 Verify that EXV Stepper Type is set to 2500 Bi-Polar at the controller display
(Settings→Equipment→Basic→2500 Bi-Polar)
- 2 Disconnect wire harness connector from controller to expose the 4 pins that connect to the EXV cable
- 3 Using a voltmeter, place the test leads between each combination of pins 1 through 4 as shown in the pictures. Set the meter to measure DC volts. Set System Enabled = "No" **(Settings→System Enabled)**. Wait for the controller to drive the valve closed.

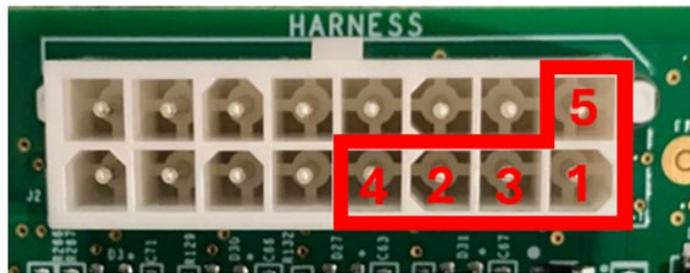
Pins 5 & 1

VERIFY CONTROLLER SIGNAL TO UNI-POLAR VALVE

- 1 Verify that EXV Stepper Type is set to 500 Uni-Polar at the controller display
(Settings→Equipment→Basic→500 Uni-Polar)
- 2 Disconnect wire harness connector from controller to expose the 5 pins that connect to the EXV cable
- 3 Using a voltmeter, place the test leads between each combination of pins 1 through 4 as shown in the pictures. Set the meter to measure DC volts. Set System Enabled = "No" **(Settings→System Enabled)**. Wait for the controller to drive the valve closed.

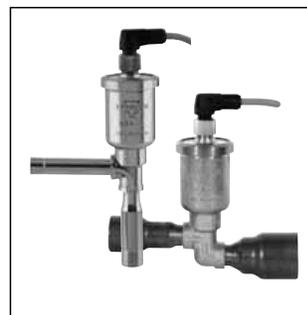
Types SER-B, C, & D

The Sporlan SER valve series are step motor operated electric expansion valves. Step motors are designed to provide discrete segments of angular motion, or rotation, in response to an electronically generated signal. The advantages of step motors in valve applications are high resolution, repeatability and reliability with low hysteresis. Feedback loops are not required, simplifying controller design and circuitry.

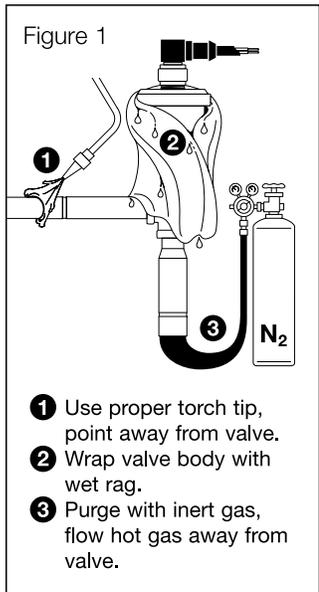
away from the motor housing and cable. See Figure 1. In order to maintain IP-67 rating on the cable interface, it is NOT recommended to remove cable during installation. If the cable is removed, take precaution to ensure water does NOT flow down into motor contact pins. Cable must be retightened to the specifications shown in Table 1. Care must be taken to assure that the cable is not damaged either directly from the flame, or indirectly from contact with hot piping. The valve is shipped in the open position to prevent heat being conducted into the motor, but it is strongly suggested that the valve body be wrapped with a wet cloth during the soldering operation. Valve internals **must not experience maximum temperature**, as shown in Table 1, during install. Inlet strainers are supplied optionally, and
