Icing In Walk-In Freezers

William Salomon
Quality Manager
HTPG
Scottsboro, Al

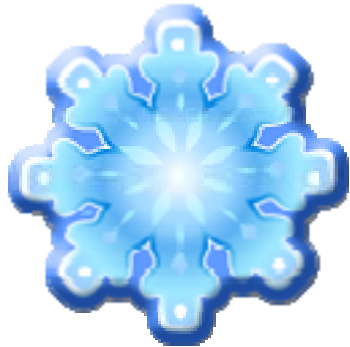
Frost or snow ice is caused by warm, moist air infiltration. It forms when water goes directly from a vapor to a solid by deposition. This is normally due to a walk-in door which is not sealing properly or air leaks at penetrations for conduit or piping. Adjustments or a new gasket, hinge or latch should solve the door leak problem. If doors are left open for extended periods of time, a strip curtain should be installed. All penetrations need to be properly sealed.

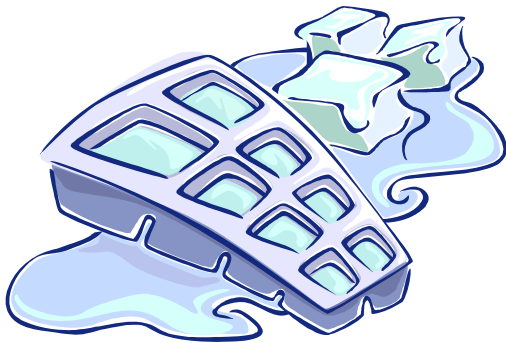
Hard, clear ice forms from water vapor coming out of the evaporator during defrost cycles. It forms when water vapor rises out of the evaporator, condenses to liquid droplets on the fan blades, fan guard and ceiling, then freezes to solid ice. This can be due to incomplete defrosts or poor drainage. If the defrost timer is set for too short a time, the cycle will terminate on time instead of temperature. Less frequently, the fan delay switch, defrost termination switch or heaters could be faulty. All drain heaters must be working properly so the condensate drains completely.

Air infiltration problems must be corrected first! After the walk-in is free of frost and snow, the defrost timer should be set to provide three to four complete defrosts every day. At the end of a defrost cycle the coil should be free of water and ice, and the condensate drain pan should be empty. The fan delay should prevent the fans from coming on until the coil has pulled down below freezing.

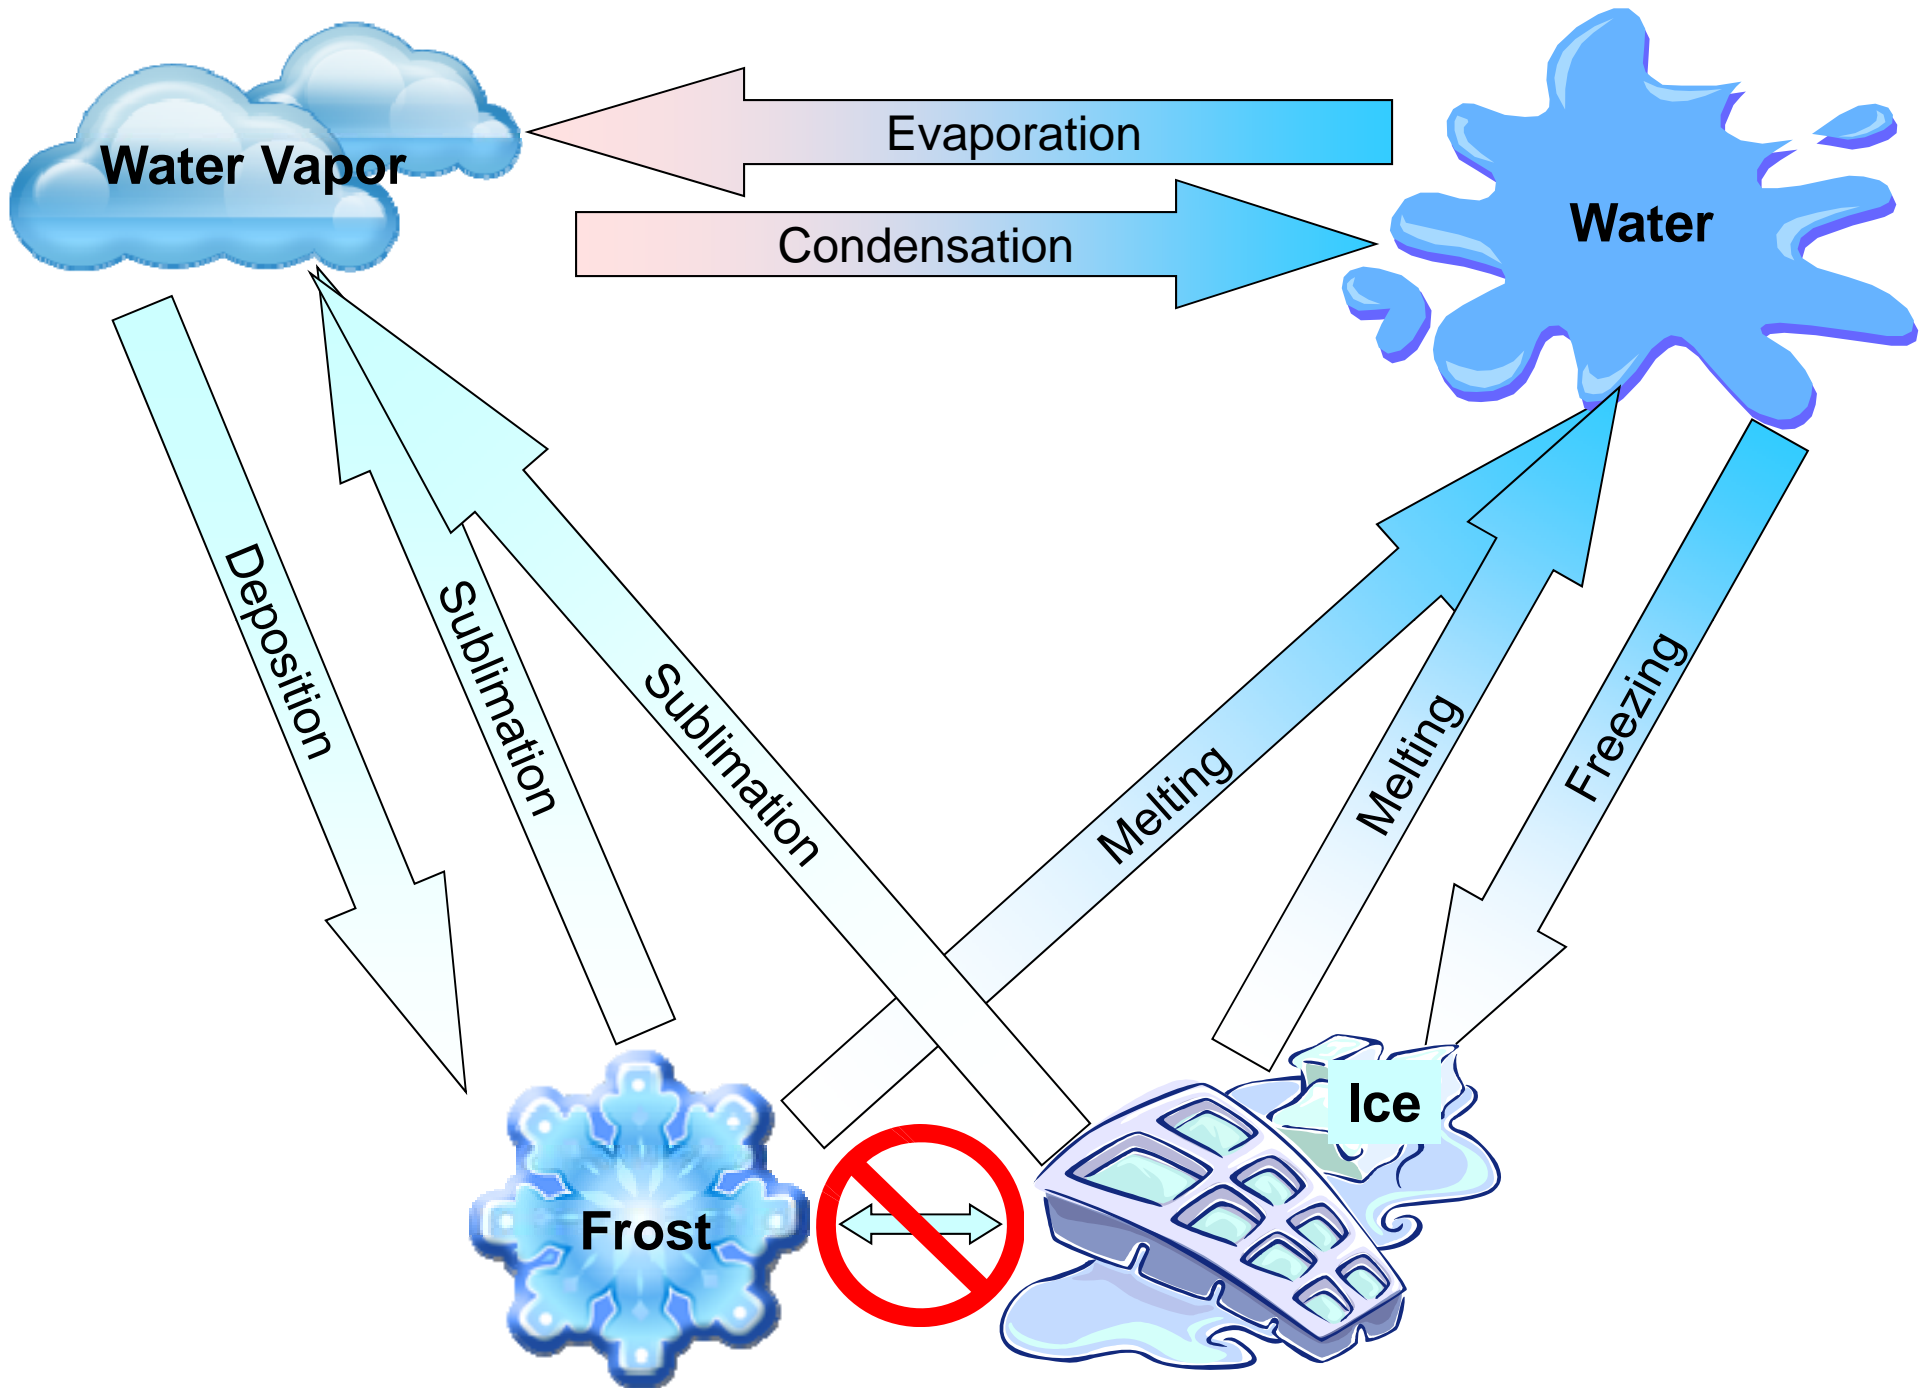
Warm, moist air being sucked around the back of the evaporator, depositing heavy frost on the ceiling.

Water vapor rising out of the evaporator during defrost, then condensing and freezing on the ceiling.
